Manhole Inspection Summary

Manhole # S59Q__003MH

Insp Date: **7/25/08 11:42 AM**

Location Address: **4300 boston st**

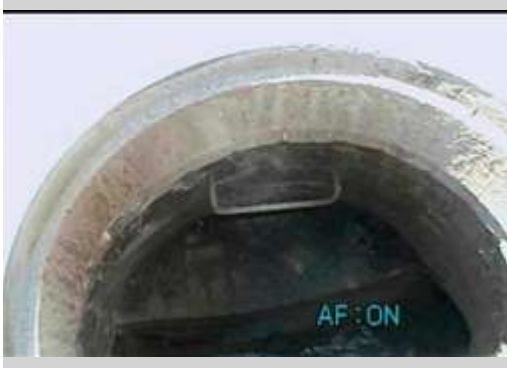
Misc.

steps

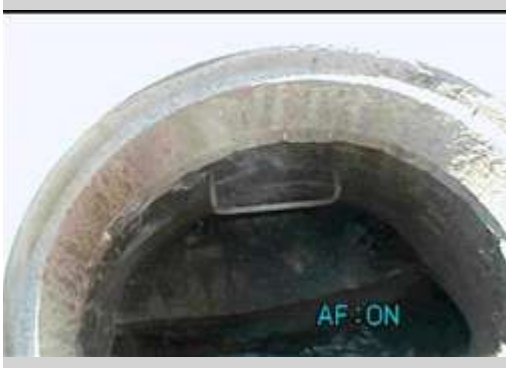
Defect 1

steps

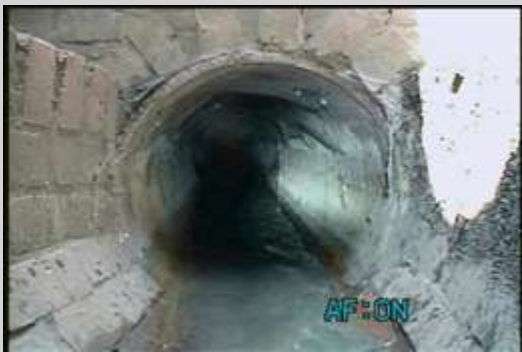
12 O'Clock Outflow

15 in. Circular Gravity Sewer
Pipe Out @ 12 O'Clock

Deposits: ☒ None ☐ Mud ☐ Sludge ☐ **Debris** ☐ Grease

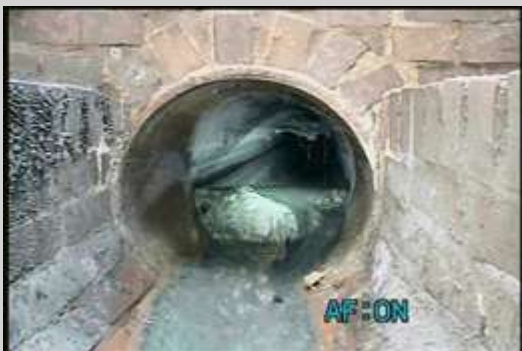
6 O'Clock Inflow

15 in. Circular Gravity Sewer
Pipe In @ 6 O'Clock

Deposits: ☐ None ☐ Mud ☐ Sludge ☒ **Debris** ☐ Grease

Silt Depth: 4 (in.) Deposits Extent: **Light**
